Inspection of the road surface condition on black spots – Croatia case study

Abstract. *In pursuit of a safe road network, adequate design, construction, and maintenance of road surfaces are imperative. However, inevitable wear and tear over time lead to damage. The previous project identifies 23 black spots on the state road network of the Republic of Croatia by analyzing traffic accidents and influential factors. The road surfaces of these black spots were meticulously examined using a specially equipped vehicle, assessing parameters such as international roughness index (IRI), macrotecture, rutting, and cracking. By employing this road surface inspection system, effective road maintenance strategies can be proposed to minimize the risk of traffic accidents.*

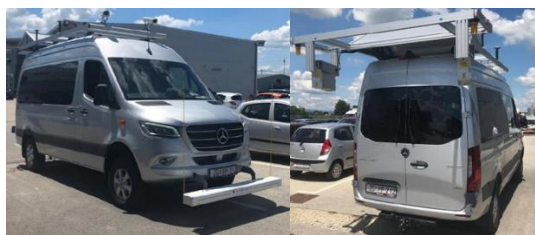
Figure 3. Special vehicle with laser profiler (left) and LCMS system (right)

The road surface condition was recorded using the Hawkeye 2000 ACD system, installed in a Croatian Roads' Ltd. specialized vehicle. This system on the vehicle consists of the following components: a laser profiler, an LCMS system for automatic crack detection, video cameras, GPS (GNSS positioning system), GPSI-TRAC 2 (a road geometry examination system), an odometer, an accelerometer, and computer hardware for data processing and storage. The laser profilometer has two lasers that measure IRI, longitudinal profile, and macrotexture. These measurements were executed using a laser bar mounted on a vehicle moving at average speed, ensuring minimal traffic flow disruption during data collection. The LCMS system consists of two 3D lasers mounted on a vehicle perpendicular to the road, emitting infrared radiation from an opening 2.2 m above the ground. Both of these systems are shown in Figure 3. Other components of the system include a control console, a DMI (Distance Measuring Instrument), an accelerometer, the HEARTBEAT central module, a computer, the Onlooker Live software for data collection, and the Processing toolkit for data processing.
